PHYSICS OF FAILURE IN ELECTRONICS, VOLUME 2 (March 1964)
Edited by M. E. Goldberg and J. Vaccaro

PHYSICS OF FAILURE IN ELECTRONICS, VOLUME 4 (June 1966)
Edited by M. E. Goldberg and J, Vaccaro

Physics of Failure in Electronics

PREFACE

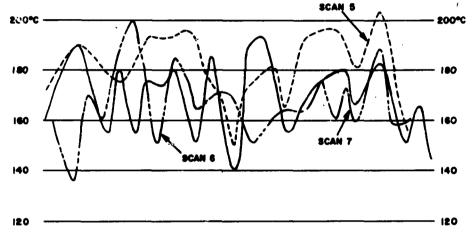
To determine if localized heating was responsible for the growth, a device that had been subjected to this same test was thermally scanned across the growth-susceptible area while operating at room temperature under the voltage stress conditions. The temperature determination scans were made with the 1.4 mil resolution lens system. The results are shown in Figure 17.

It is observed from the scans in Figure 17 that temperatures in the range of $180\,^{\circ}\text{C}$ to $200\,^{\circ}\text{C}$ were detected

when the device was operated at room temperature. This would indicate that temperatures as high as 325°C could initially occur during operation in a 125°C ambient. An investigation of the operating circuit by probing has indicated that preferential electrical opening of certain internal nodes can cause a current as high as 120 ma to flow through the $V_{\rm CC}$ connection to the device. It has also been determined that leakage paths not indicated in the device schematic can be thermally activated, causing current flow as high as 100 ma in any of the blackened areas shown in Figure 16. Tests conducted at 25°C have shown that a current flow of 200 ma through the V_{CC} connection with no other stresses applied is sufficient to cause a black growth to occur in less than one minute. A current flow of 180 ma through all 8 diodes (in parallel as in the test circuit) is sufficient to induce the black growth at room temperature. It is concluded that the failure mode is one or more of the high temperatureactivated mechanisms previously discussed, i.e., disappearing metalization which causes internal opens and hence increases the current flow through certain regions, which then raises the device temperature sufficiently to cause the formation of an Al-Si eutectic.

Temperature scans across device operating under stress voltage conditions.

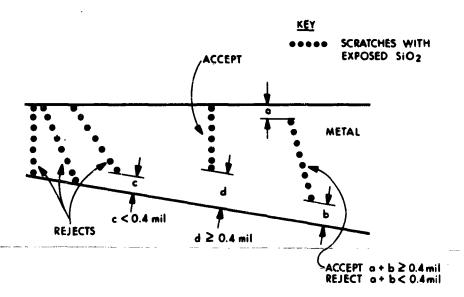
Fig. 1. Examples of acceptable and rejectable devices for scratches. Note that only those scratches which expose silicon dioxide somewhere along the scratch shall cause rejection.

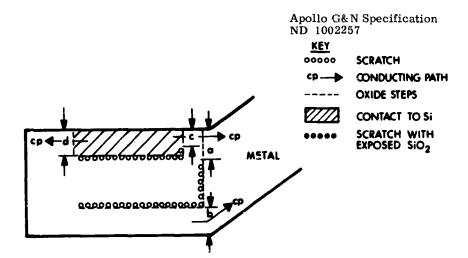
Fig. 2a. ACCEPT, a+b AND $c+d \ge 0.6$ mil. REJECT, a+b OR c+d < 0.6 mil.

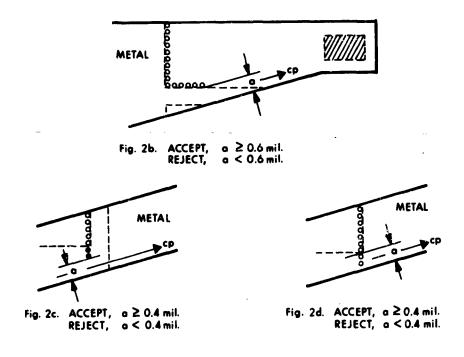
Fig. 2. Examples of acceptable and rejectable devices for scratches at or along oxide steps.

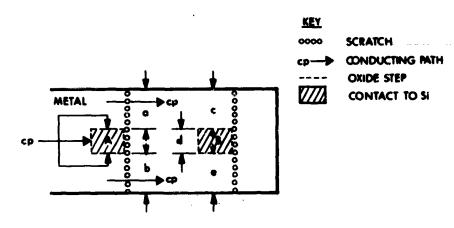
Fig. 2e. ACCEPT, $a+b\geq 0.4$ mil. REJECT, a+b<0.4 mil SINCE THE CONDUCTING PATH TO CONTACT B IS AFFECTED.

ACCEPT, c+d+e≥0.6 mil SINCE THE CONDUCTING PATH TO CONTACT B≥0.6 mil AND NO OTHER CONTACT IS AFFECTED.
REJECT, c+d+e<0.6 mil.

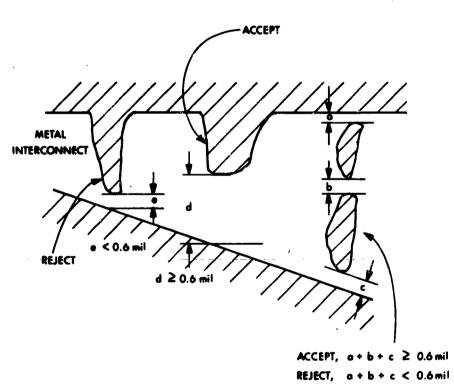
Fig. 3. Examples of acceptable and rejectable devices for voids in the metal interconnect. Note that the conditions for accept or reject are the same as for scratches (Fig. 1) except that the minimum acceptable distance is larger.

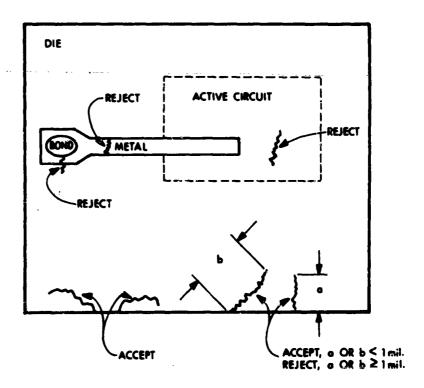
Fig. 6. Examples of acceptable or rejectable devices for cracks in the die.

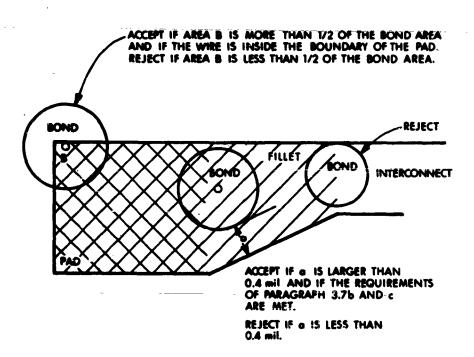
Fig. 7. Examples of acceptable and rejectable devices for bond placement. Pad, fillet, and interconnect areas are to be negotiated.

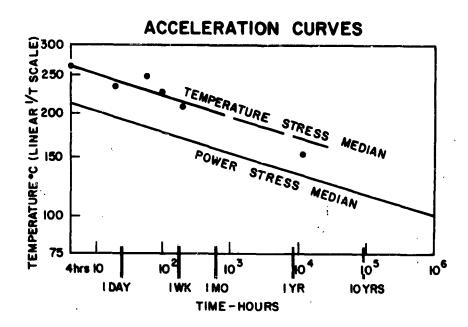
Figure 7

The mechanism which caused failure of this device during power and temperature aging is believed to be diffusion of gold from the base contact through the 0.15μ base layer to the collector-base depletion region, or migration of gold or silver or both under the SiO_2 and down the mesa to the collector base junction. Such migration has been observed. The gold diffusion through the base probably takes place along strain lines set up in

the base layer when the emitter region is alloyed. These beliefs are supported by the 1.6 ev activation energy resulting from these tests.

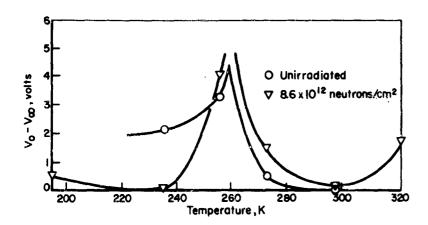
Figure 8

rate of 10 vacancy-interstitial pairs per neutron per cm, and a radiation level of 8.6×10^{12} neutrons/cm², a 6 per cent efficiency of the vacant lattice sites coalescing with interstitial copper atoms is required--not an unreasonable value.

Temperature Dependence of the Magnitude of the Breakdown Voltage Transient Before and After Exposure to 8.6 x 10¹² Reactor Neutrons/cm²

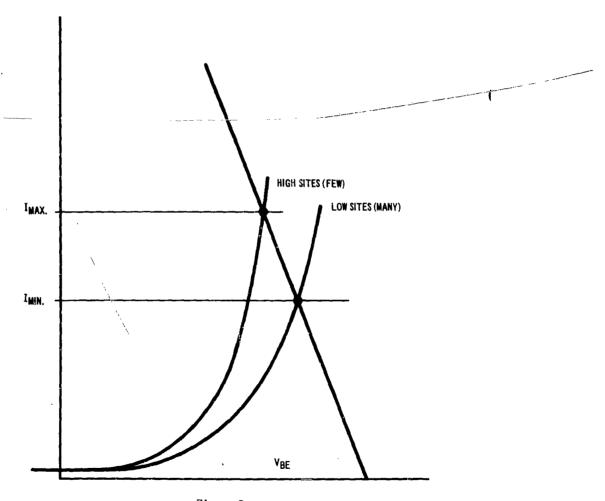
Figure 3

in Fig. 3. The I_E vs. V_{BE} characteristics must be obtained under the actual conditions of temperature and collector voltage that will apply. Then the maximum permissible site current I_{max}, and the minimum desired site current I_{max} are assigned. The intersection of these abscissae with the extreme cases of the characteristics will determine a load line that corresponds to an appropriate resistance. (See Appendix):

Load Line Determination of Ballast Resistance

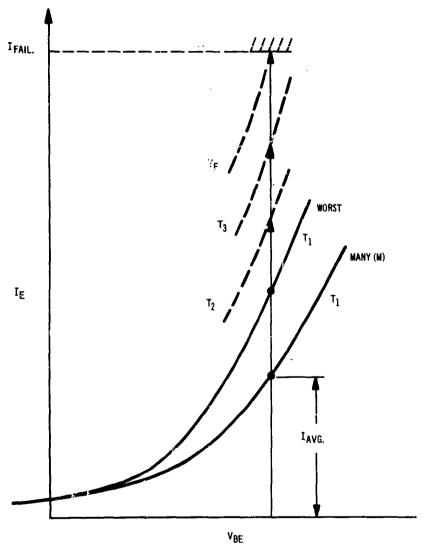
Figure 9

A possible effect on second breakdown of eliminating current-hogging in this way is offerred with the aid of Figs. 9, 10. In Fig. 9 for constant-voltage we see the I-V curves for both the worst site and the large number (m) of average sites. The intersection of these characteristics with the bias voltage ordinate gives the respective currents drawn. If the situation is stable nothing further occurs. But if the temperature-current situation is not stable for the worst site, then it will begin to draw more current and attain higher temperatures. This is shown for the worst site by the intersection of the bias-voltage ordinate with the I-V characteristics drawn for higher temperatures. The process is terminated when the worst site achieves some temperature T_F at which it draws a maximum current that causes it to be destroyed (T_{FAIL}).

The entire process occurs without any change in VBE, and thus both the bias and the current to all the other sites remains unchanged. At failure, the total current drawn by the transistor is the sum of the failure current to the worst site plus m-times the current drawn by the average sites.

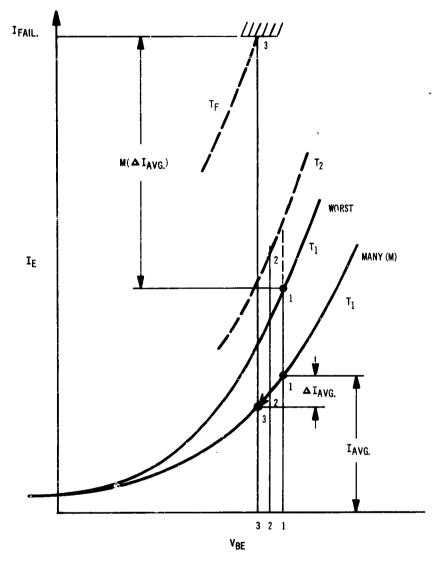
In Fig. 10 for the constant-current case the same initial I-V curves are shown. The process to be described is a dynamic one, but must be outlined by several discrete steps. The initial condition of bias is the ordinate "1" whose intersection with the characteristics gives the initial currents. If the worst site is unstable under this bias then it will tend toward higher currents and temperature. Its static impedance decreases and thus the load impedance presented to the base generator is reduced. The generator voltage decreases slightly as shown by ordinate 2. This reduces the average current to the many sites by some increment and makes available m-times this increment to the worst site. With this additional current the worst site can rise to some higher current and temperature shown by the intersection of ordinate 2 with the I-V characteristic for temperature T₂.

Since the worst site will be unstable at T_2 , its impedance will decrease further and the process described will repeat, moving the voltage ordinate from 2 to 3. Fig. 10 shows this final change as producing failure by second breakdown. At failure the total current drawn by the transistor is the sum of the failure current to the worst site plus m-times the reduced current drawn by the average sites. This reduction in average current could lead to lower second-breakdown power under the constant-current condition.

$$\begin{split} I_{TOTAL} &= I_{FAIL} + (M) \left(I_{AVG.} - \Delta I_{AVG.} \right) \\ &= I_{FAIL} + (M) I_{AVG.} - (M) \left(\Delta I_{AVG.} \right) \\ &\text{Figure 10} \end{split}$$

plus m-times the <u>reduced</u> current drawn by the average sites. It is this reduction in average current which may account for the smaller breakdown power seen under the constant-current condition.

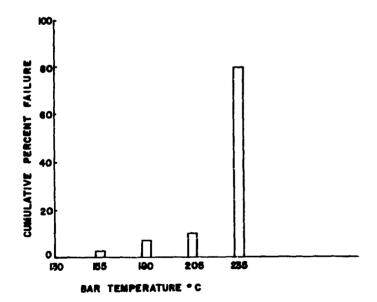
Figure 12 graphs cumulative percent failure as a function of bar temperature for the step stress test. Bar temperature was determined by the equation

The graph shows ω sharp increase in the rate of failure after the bar temperature exceeded 200°C.

BAR TEMPERATURE VS CUMULATIVE % FAILURE SN355 DRIVE SWITCH OPERATING STEP STRESS

Examination of the failures revealed melted evaporated leads in all cases on the pin 8 side of the R2, R3, and R4 resistor. Figure 13 is a photomicrograph of the bar with arrows to indicate the location of the open leads. The

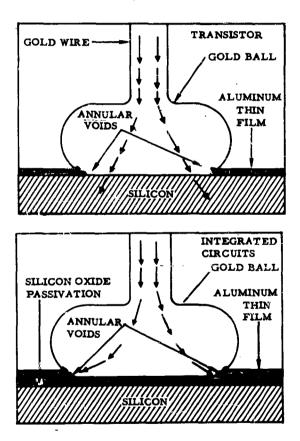
Figure 15.

The mechanism whereby a bond becomes open or intermittent in electrical behavior but mechanical integrity is retained has already been described – the diffusion of gold from the bond to form or enlarge cracks or voids. When a void extends from the outer periphery of the bond inward and downward to the $\mathrm{Si0}_{x}$ film on the silicon die, electrical isolation from the conductor stripe and the active region will occur (Figure 15). If the void gap is small, thermal fluctuations could cause intermittent contact to be made.

Typical TC Bond Configurations for Transistors (Top) and ICs

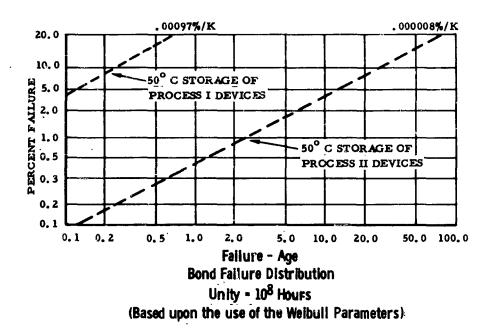
Figure 16.

Bond Failure Distribution

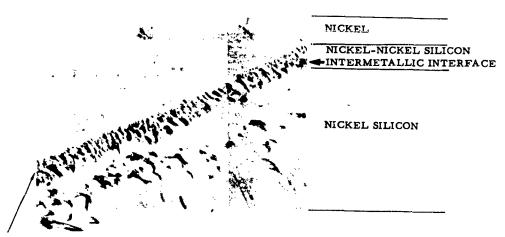
The postulation made on the nickel-silicon intermetallic formation weakening the brazement resulted from the metallographic examination of the supplier CQAP test parts. Some of the devices that had been exposed to the more extreme thermal conditions exhibit ruptures in the die-to-pedestal brazement. Figure 9 shows a high magnification of the rupture. The rupture always took place adjacent to a light blue colored compound. Electron microprobe traces, also shown in Figure 9, show the blue phase to be a nickel-silicon alloy. The presence of the nickelsilicon alloy at the rupture point prompted a characterization study. Three nickel-silicon compounds were synthesized as metallurgical standards for the electron probe. The compounds were identified by X-ray diffraction. Microhardness readings indicated all the compounds were very hard and brittle. Microprobe traces utilizing the standards identified the nickel-silicon alloy in devices as an intermetallic compound with the stoichiometric ratio of Ni3 Si2. Electron microscope replicas of diffusion samples (as well as devices) exhibited a row of very small voids at this interface as shown in Figure 10. This row of voids was attributed to the Kirkendall effect where the nickel diffuses more rapidly through the intermetallic zone than the silicon diffuses within the intermetallic zone.

Photomicrograph and Electron Probe Trace on Ruptured Die-to-Header Brazement of Power Transistor (Subjected to Temperature Cycling -85 to 315 C)

NOTE POROSITY AT THE NICKEL-NICKEL SILICON INTERMETALLIC INTERFACE

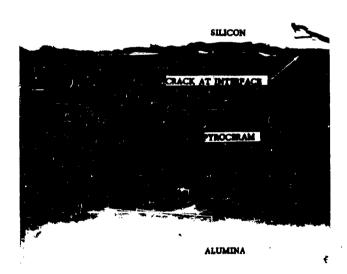
a. Cross-Section Showing Relative Material Thicknesses

b. High Magnification of Crack at Pyroceram Silicon Interface 740%

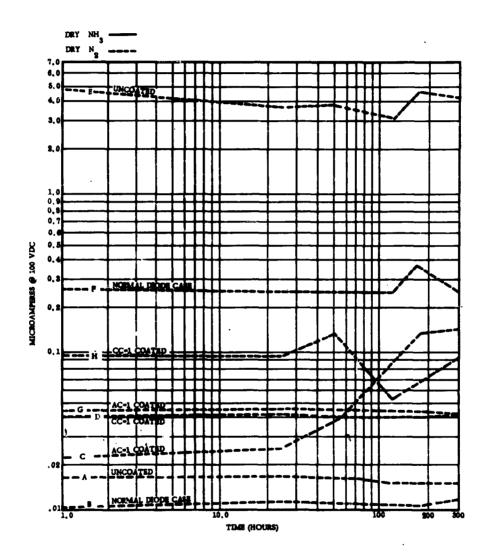
Figure 9

Diode Leakage in Dry Ambients

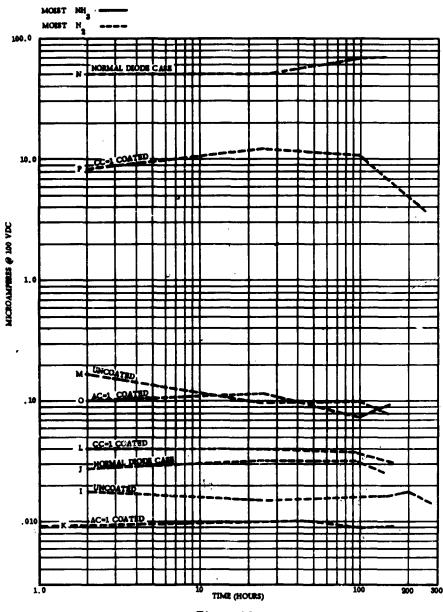
Figure 10

1. Diode Ammonia Exposure. As indicated previously, ammonia was found in the AM-1 molding compound used by a vendor to encase diodes. To evaluate the effect of ammonia gas environments on diodes, bare and passivated or passivated coated with one of several plastic systems were exposed to the different gas environments and 100-vdc reverse bias. Table 12 presents the protective plastic systems and the test conditions. Due to the insufficient number of test diodes available initially, only three or four were used in each combination of protective coatings and gas environment. The dry ammonia and dry nitrogen gases used in these tests were as received from the manufacturer. Calculations based on the moisture maximum content specified for the ammonia revealed that it contained less moisture than air dried over calcium chloride. The moist gases were obtained by bubbling the dry nitrogen and the dry ammonia through water and concentrated ammonium hydroxide, respectively, which were then filtered through glass wool prior to injecting into the test chamber, which consisted of a test tube containing the mounted diode with electrical connections. Reverse bias voltages were applied to the diode under these test conditions after approximately 24 hours of exposure to the gases. The results including average reverse currents as a function of time are shown in Figures 9 and 10 and indicate that higher and more erratic currents are obtained in the presence of ammonia. In comparison

Diode Leakage in Moist Ambients

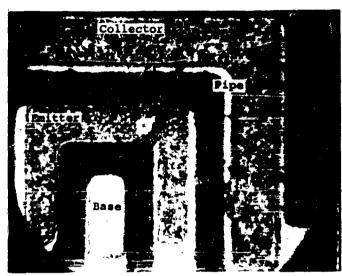
Figure 3

Lack of Expected N-Reaction In Emitter Window Indicates Pipe Down To P-Base Region

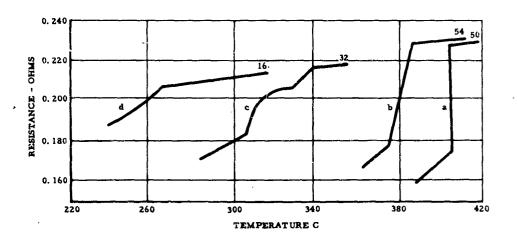
Figure 27
Copper-Gold Phase Diagram

The concentration of gold in the braze alloy is a critical factor. As apparent in the copper-gold phase diagram, Figure 27, a solid-state phase transformation can occur in copper-gold alloys containing over 45 weight percent gold (Ref. 9). This phase transformation will occur at temperatures encountered in the high-stress testing to which these transistors had been subjected. Accompanying the phase change is an increase in electrical resistance which will vary from 16 to 54 percent in the temperature range encountered, Figure 28 (Ref. 10). It was calculated that these changes in electrical resistance could readily cause drift in the saturation voltage,
